Halswell School, 1 School Rd, Halswell,
Christchurch 8025

Author: Craig Taylor Date: June 2021

- 1.1 This arboricultural report was commissioned by Stuart Cameron, Principal, Halswell School, as to the feasibility of installing an Astro Turf play area in the vicinity of several mature trees at Halswell School, 1 School Road, Halswell, Christchurch, (Halswell School) (images 1 and 2).
- 1.2 The trees are identified as 11x *Quercus robur* – English Oak (English Oak). 10 of the English Oak trees are growing as a single stand with the remaining English Oak tree located northwest of the stand and which will *not* be impacted by the proposed work (image 2).
- 1.3 The English Oaks have been attributed a unique ID number for ease of identification for this report (image 2).

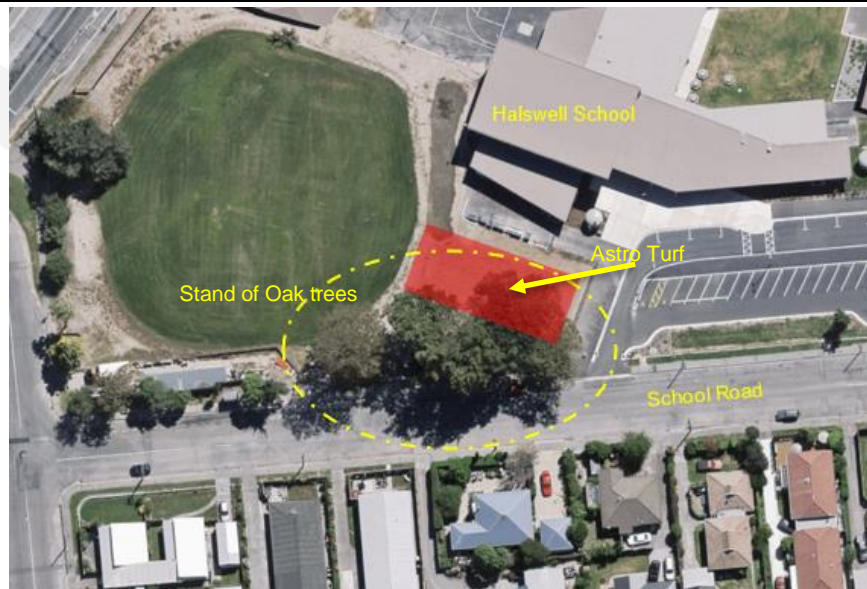
Image 4: The proposed location of the Astro Turf play area at Halswell School in relation to the stand of Oak trees.

7.2 It is the recommendation of the author that 6.4.1 Maintain the status quo and either (i) do not proceed with the proposal with installing the Astro Turf play area in the vicinity of the trees or (ii) relocate the Astro Turf play area away from the trees to another area is the only viable option.

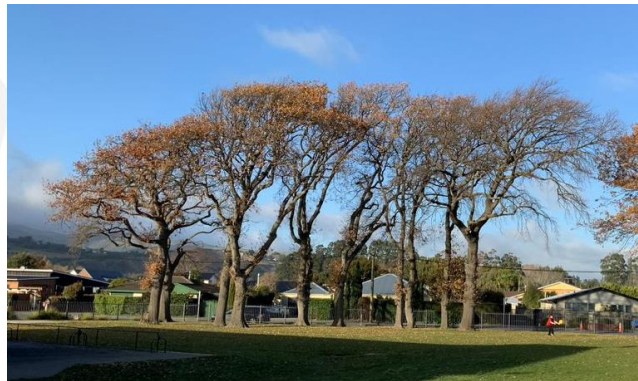
<p>Image 5</p>
Tree species:	10x Quercus robur – English Oak	
Date of plantings:	Circa. 1925	
Height:	15.0-19.0m	
Canopy spread: (east – west)	45.0m (measured as a single canopy)	
Diameter at breast height:	0.4-0.9m	
Health:	3	
Structure:	4	
Overall:	4	
Life expectancy:	15-25+ years (if the current status quo is maintained).	
<p>Comments: The trees were assessed as a single entity and are all classed as having the same health and structure.</p> <p>Trees are multi stemmed from 3m+ (species characteristic).</p> <p>Trees have high canopies.</p> <p>Trees have weighted elongated limbs due to growing as a single canopy and where there has been limited space from neighbouring trees and have adopted a phototropic (growing towards light) growth.</p> <p>Tree canopies HS01/HS02/HS03/HS04/HS10 asymmetrically weighted north/northeast.</p> <p>Tree canopies HS05/HS06/HS07/HS08 asymmetrically weighted south/southeast toward School Rd.</p> <p>Pockets of decay evident on all trees from lower lateral branch removals through natural branch failures or pruning.</p> <p>Minimal epicormic growth or wound occlusion evident.</p> <p>Trees appear to be in senescence with minimal incremental branch tip growth evident.</p>

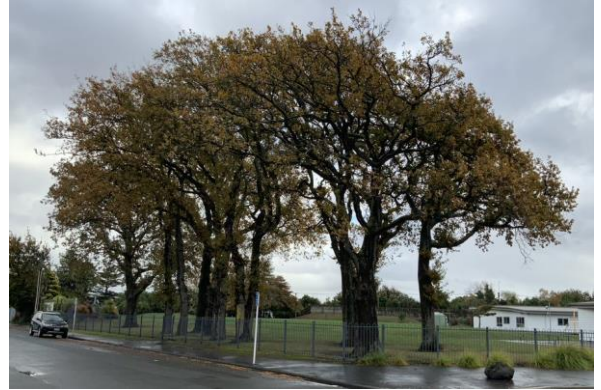
Image 6

5.2.2 Trees HS05/HS06/HS07/08 overhang and are weighted towards School Rd by approx. 3-5m (image 6).

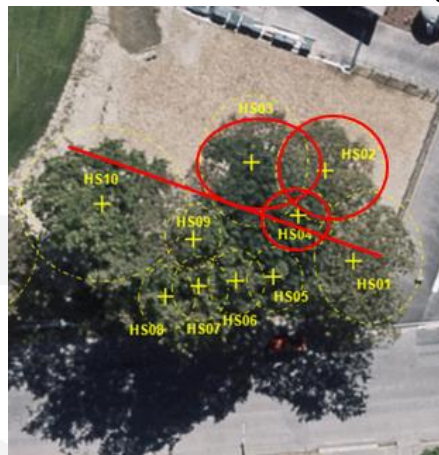
6.4.2 Remove trees HS02/HS03/HS04 and retain the remaining trees.

Discussion – The Oak trees have grown as a single entity and should be treated as such with being planted around the same time. The removal of trees amongst the stand **will** impact on the neighbouring trees that have been retained. Trees that have grown as a stand and as a single entity have grown offering protection and shelter to neighbouring trees and have moved dynamically as a single entity during weather events. The removal of trees HS02/HS03/HS04 will expose trees HS01/HS05/HS06/HS07/HS08/HS09/HS10 to wind forces they are unaccustomed to and a domino effect of failures will more than likely occur over the coming years.

Recommendation – This option is **not** recommended due to the reasons outlined and that, in my opinion, failures will more than likely occur on the remaining trees HS01/HS05/HS06/HS07/HS08/HS09/HS10 and that section 6.2 and 6.3 of this report has been considered in collaboration with the recommendation.

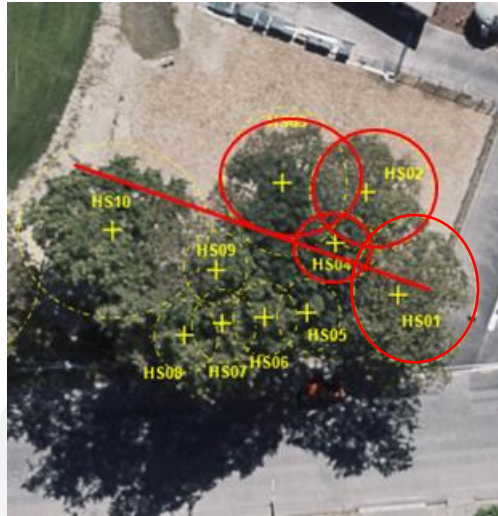
6.4.3 Remove trees HS01/HS02/HS03/HS04 and retain the remaining trees.

Discussion - These trees have grown as a single entity and should be treated as such. The removal of trees amongst the stand **will** impact on the neighbouring trees. Trees that have grown as a stand and a single entity have grown offering protection and shelter to neighbouring trees and have moved dynamically as a single entity during weather and the removal of trees HS01/HS02/HS03/HS04 will expose trees HS05/HS06/HS07/HS08/HS09/HS10 to wind forces they are unaccustomed to and a domino effect of failures will more than likely occur over the years.

Recommendation – This option is **not** recommended due to the reasons outlined and that, in my opinion, failures will more than likely occur on the remaining trees HS05/HS06/HS07/HS08/HS09/HS10 and that section 6.2 and 6.3 of this report has been considered in collaboration with the recommendation.

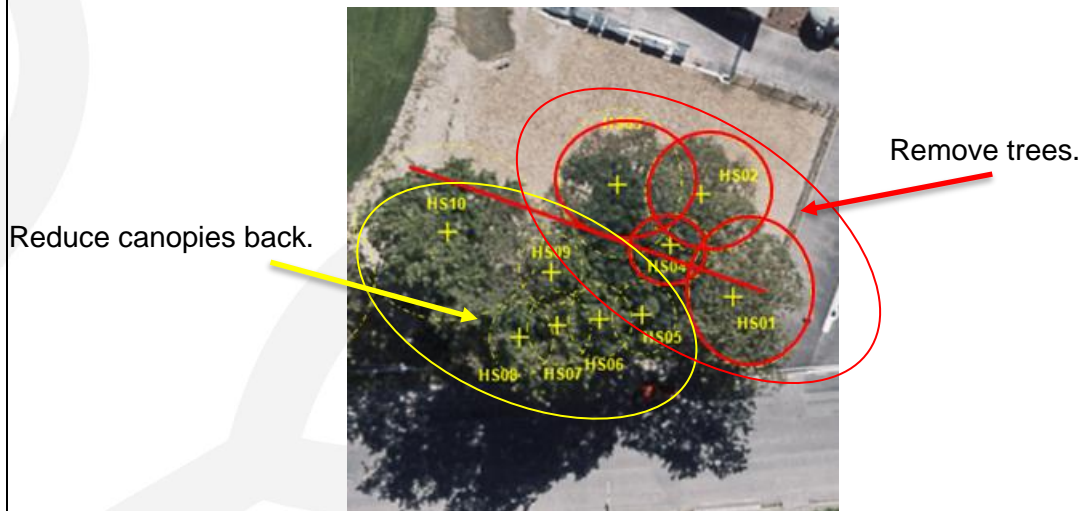
6.4.5 Remove trees HS02/HS03/HS04 or remove trees HS01/HS02/HS03/HS04 and reduce the canopies back on the remaining trees.

However, these Oak trees are in senescence i.e. that they are no longer putting on incremental yearly growth on the outer canopy (this is also evident in the lack of epicormic growth and the lack of occlusion around some of the wounds as the trees are unable to respond or adapt to the damage due to their age etc.) but are producing leaves, producing and dropping acorns and dropping the leaves annually.

Pollarding or reducing the canopies back will lessen the risk from failures but the likelihood is that these trees would not respond favourably to the reduction work. This would, in my opinion, lead to a decline in their health as they are unable to respond to the work carried as the productive leaves which are essential for the trees to produce energy and sustain life (through the photosynthesis process) will have been drastically reduced due to the canopy reduction work and could increase the health and safety risk longer-term to pedestrians on School Rd and within the school grounds if not managed appropriately.

In my opinion, if pollarding or canopy reduction work is carried out the trees will continue on for several years living off the energy reserves they have stored but will ultimately go into a steady decline to the point of the trees becoming a health and safety concern.

Removing trees HS02/HS03/HS04 or removing trees HS01/HS02/HS03/HS04 and reduce the canopies back on the remaining trees is **not** the recommended option for the reasons outlined.
