Halswell School, 1 School Rd, Halswell,
Christchurch 8025

Author: Craig Taylor Date: June 2021

- 1.1 This arboricultural report was commissioned by Stuart Cameron, Principal, Halswell School, as to the feasibility of installing an Astro Turf play area in the vicinity of several mature trees at Halswell School, 1 School Road, Halswell, Christchurch, (Halswell School) (images 1 and 2).
- 1.2 The trees are identified as 11x *Quercus robur* – English Oak (English Oak). 10 of the English Oak trees are growing as a single stand with the remaining English Oak tree located northwest of the stand and which will *not* be impacted by the proposed work (image 2).
- 1.3 The English Oaks have been attributed a unique ID number for ease of identification for this report (image 2).

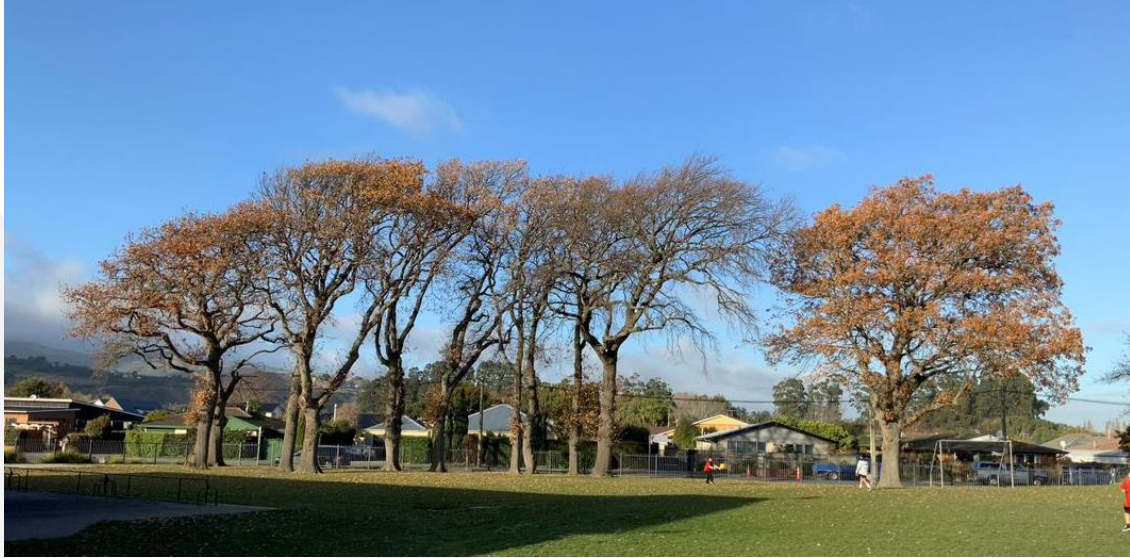
Image 3: 11x English Oak trees at Halswell School, Halswell, Christchurch.

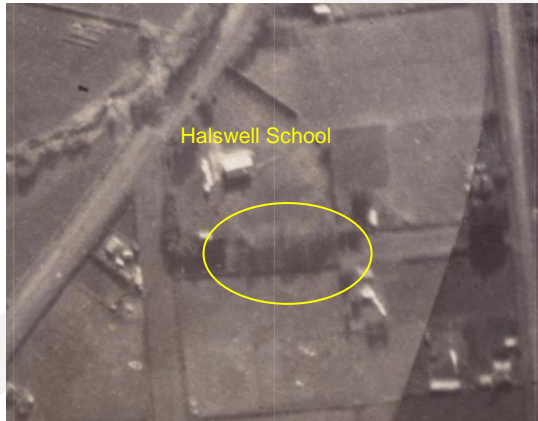
5.4.1 The school is dated 1864 and the trees appear on historical aerial imagery circa. 1925 (source: <https://apps.canterburymaps.govt.nz/CanterburyHistoricAerialImagery/>) and appear to have been planted to offer protection to the school from southerly winds (images 7 and 8).

Image 7: Circa.1925

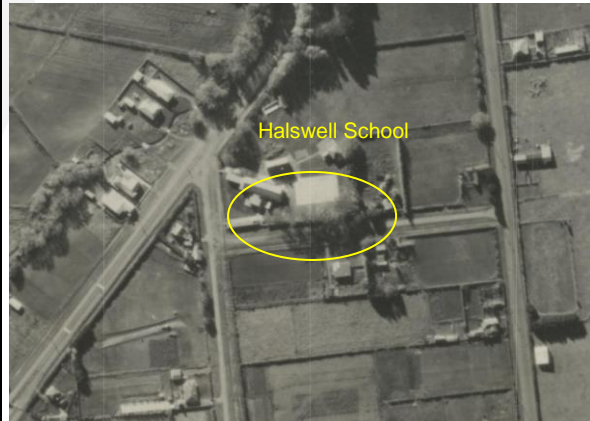
Image 8: Circa.1955

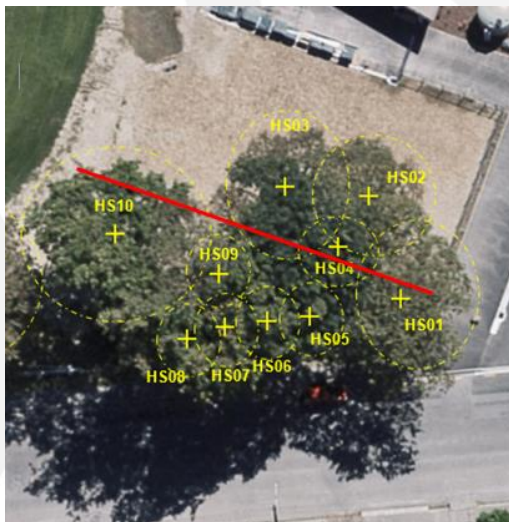
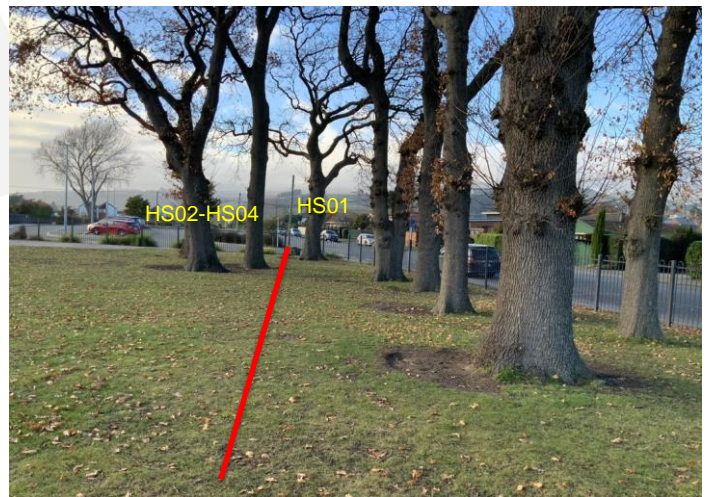
6.1 The proposed Astro Turf play area alignment will be between trees HS01 and HS04 (image 9 and 10).

7.2 It is the recommendation of the author that 6.4.1 Maintain the status quo and either (i) do not proceed with the proposal with installing the Astro Turf play area in the vicinity of the trees or (ii) relocate the Astro Turf play area away from the trees to another area is the only viable option.
